**DAM SAFETY INSPECTION  
REPORT**

**DAN RIVER STEAM STATION  
ROCKINGHAM COUNTY,  
NORTH CAROLINA**

**PAUL C. RIZZO ASSOCIATES, INC.  
101 WESTPARK BOULEVARD, SUITE B  
COLUMBIA, SOUTH CAROLINA USA 29210**

**PROJECT NO. 09-4157  
JULY 2009**

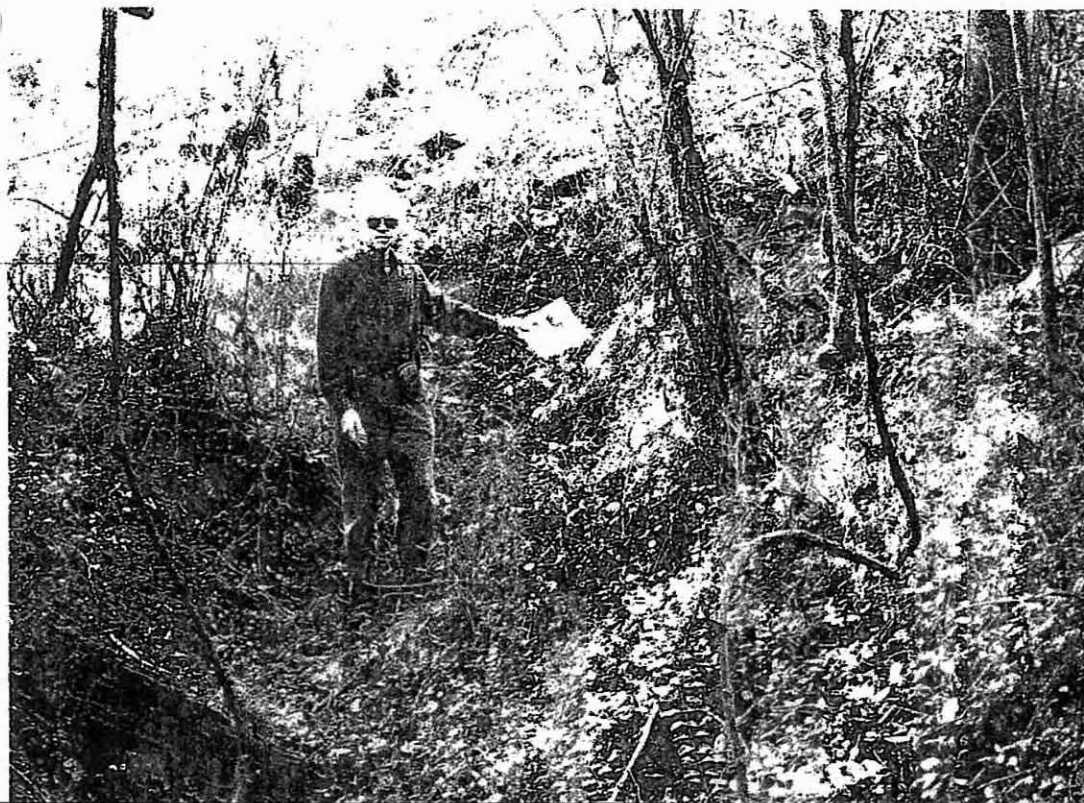
Photograph 28A

Upstream slope of secondary basin at discharge structure; note erosion or wave cutting first visible in 1996 that was not visible in 2001 due to vegetation.

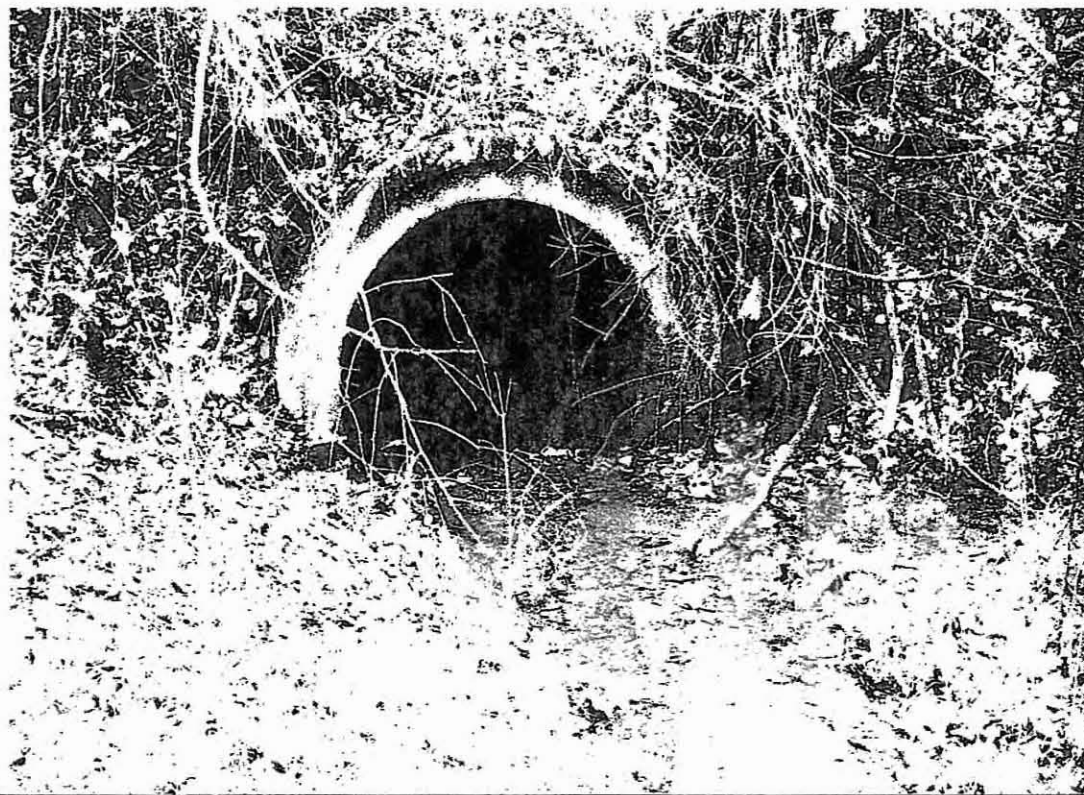
**Photograph 28B**

Gully begins at toe of dike. No apparent change since 2001.

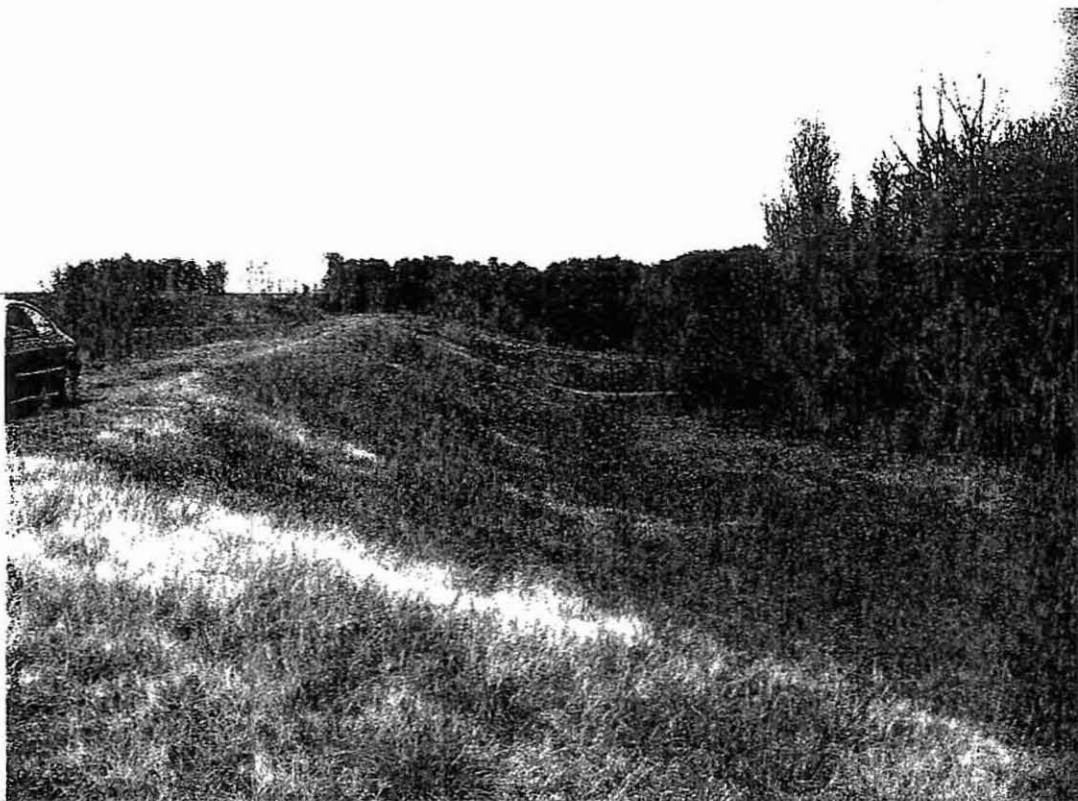
**Photograph 30**

Main dike for dry pond basin, E-NE view. Note continued presence of low place in crest apparently due to settlement.
